**CAROLINA POWER & LIGHT
MAYO ELECTRIC GENERATING PLANT**

**MAYO CREEK DAM
ASH POND DAM
PERSON COUNTY, NORTH CAROLINA**

**FIVE-YEAR INDEPENDENT CONSULTANT INSPECTION
AS REQUIRED BY
NORTH CAROLINA UTILITIES COMMISSION**

December 22, 1999

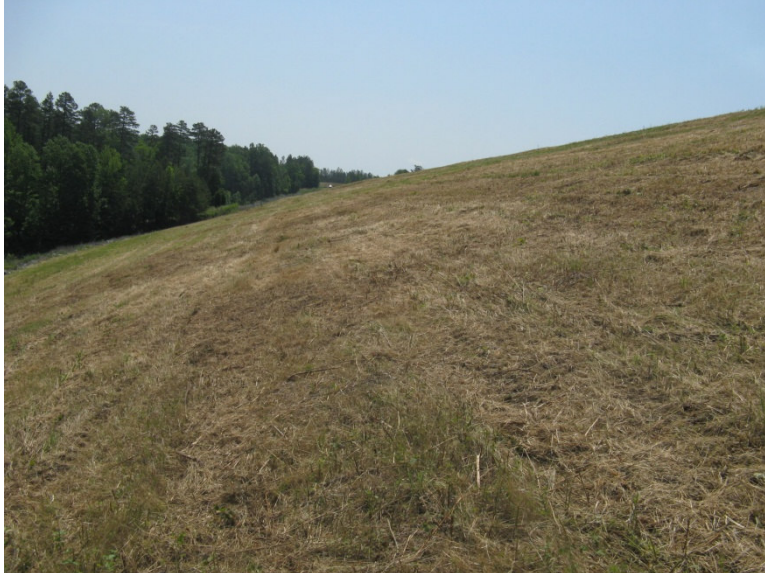
Photo 6: View of Left Groin and Embankment, Left Groin, Photo: 032, 6/3/09
(Note right and left are referenced from observer facing downstream)
